NASA TM-78897

**A COMPARISON OF THE LUBRICATING MECHANISMS OF
GRAPHITE FLUORIDE AND MOLYBDENUM DISULFIDE FILMS**

TECHNICAL PAPER to be presented at the
Second International Conference on Solid Lubrication
sponsored by the American Society of Lubrication Engineers
Denver, Colorado, August 14-18, 1978

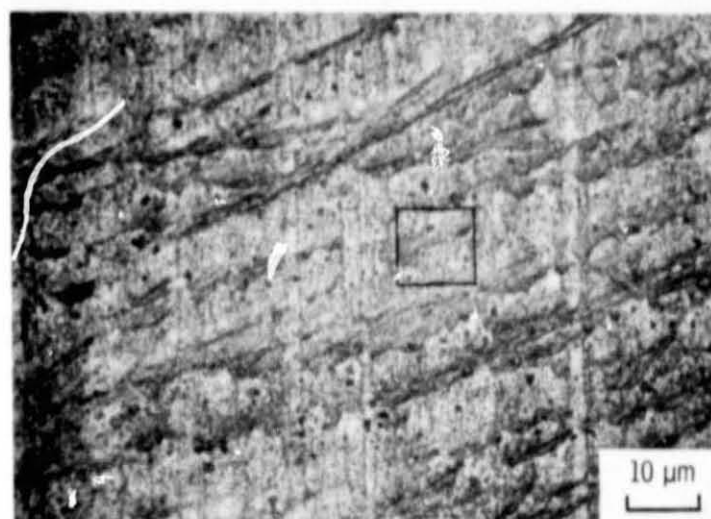
(a) GRAPHITE FLUORIDE RUBBED FILM.

Figure 1. - Photomicrographs and surface profiles before friction and wear test were performed.

(b) MOLYBDENUM DISULFIDE RUBBED FILM.

surfaces by mechanically rubbing it over the surface at constant load (see Procedure Section). The thickness of the films obtained were found to be in the order of $1\text{ }\mu\text{m}$ above the highest feature on the sanded metallic surface for the graphite fluoride film and about $2\text{ }\mu\text{m}$ for the MoS_2 film. Photomicrographs and surface profiles of the rubbed films are shown in Fig. 1.

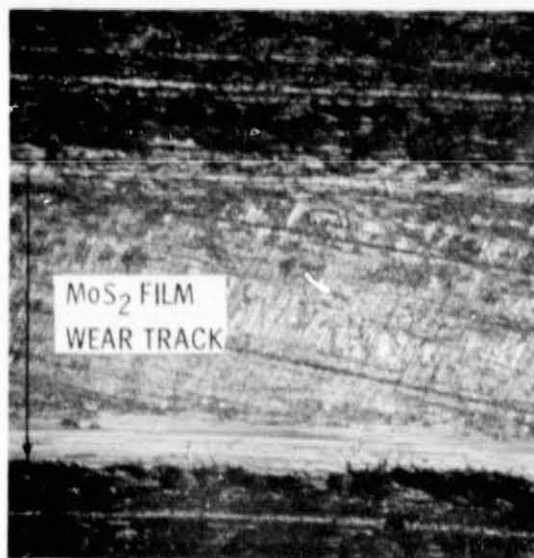
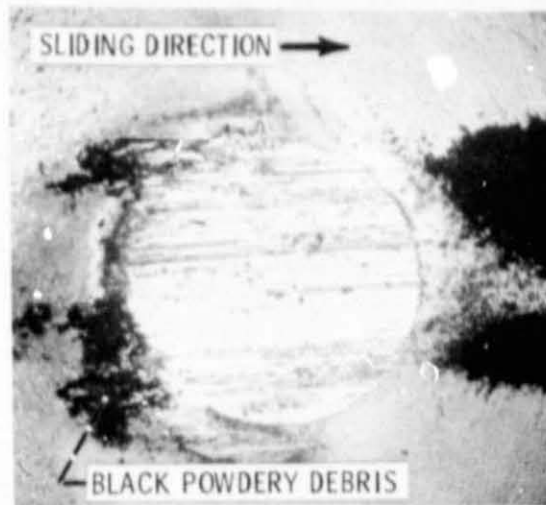
(a) 1 kc OF SLIDING.

Figure 6. - Photomicrograph of rider wear scars and MoS₂ film wear tracks taken after various sliding intervals in a moist air atmosphere (10,000 ppm H₂O).

(b) 5 kc OF SLIDING.

(c) 10 kc OF SLIDING.

The first atmosphere to be discussed is an atmosphere which might be considered a typical condition; that is, an atmosphere of 50 percent relative humidity air at 25°C (10 000 ppm H_2O). Figure 6 shows the sliding surfaces after 1, 5, and 10 kilocycles of sliding.

After only 1 minute of sliding (fig. 6(a)), a large buildup of MoS_2 is seen in the entrance region of the scar. The MoS_2 is powdery at the leading edge, but it becomes highly compressed towards the contact region. In fact, in the contact region, the MoS_2 particles coalesce and it is impossible to distinguish individual particles. The coalesced MoS_2 film tends to plastically flow across the contact area and then break up into fine powdery material in the exit. Coalescing and plastic flow seem to be characteristics that good solid lubricants possess. Silney (12) has observed this with an optical microscope by viewing dynamically various solid lubricant powders, as they pass through the contact area of a metal ball sliding on a glass disk.

Figs. 6(a) and 7(a) after 1 kilocycle of sliding. In the center of the wear track most of the original film has been plowed away and what remained was compacted MoS_2 in the sanded scratches. The MoS_2 tended to flow from the scratches in very thin films across the flat metallic plateaus between the scratches.

After 10 kilocycles of sliding, failure occurred (a friction coefficient of 0.30). Figure 6(c) shows the sliding surfaces after failure. No smooth, condensed MoS_2 films were found on either the rider or the wear track. Instead, a heavy, rippled powdery film was found on both rider and disk sliding surfaces (fig. 7(c)). It is interesting to note that failure was marked by the buildup of a heavy transfer film on both surfaces and that no galling was evident on either surface.

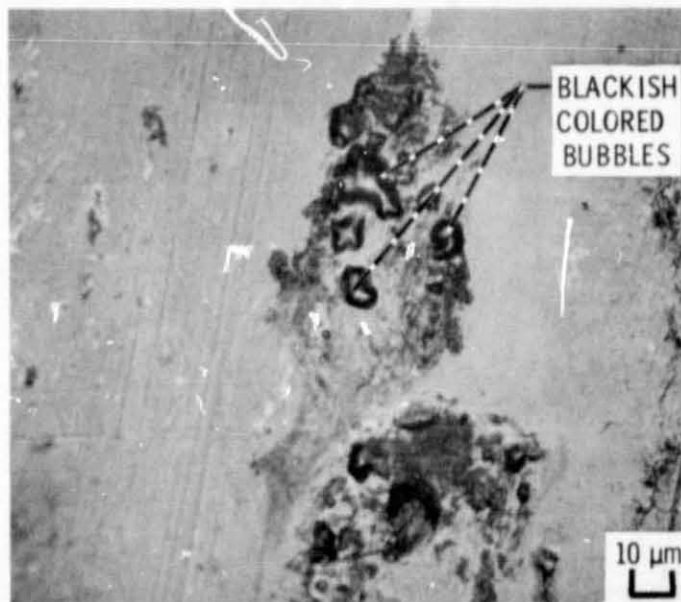
(a) 5 kc OF SLIDING.

Figure 9. - Photomicrographs of MoS₂ film wear tracks taken in a dry air atmosphere (<20 ppm H₂O).

(b) 60 kc OF SLIDING.

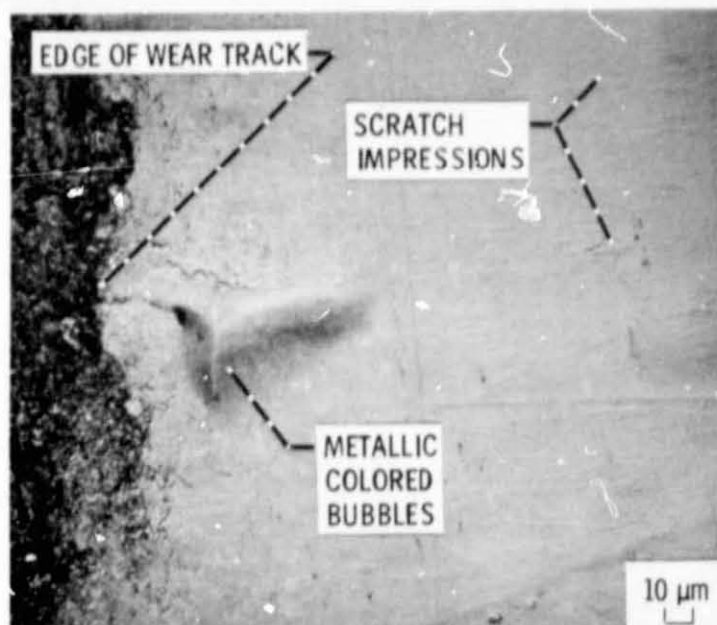
(a) 1 kc OF SLIDING.

(b) 60 kc OF SLIDING.

Figure 10. - High magnification of MoS₂ film wear tracks which were obtained in a dry argon atmosphere (<20ppm H₂O) after various sliding intervals.

(c) 700 kc OF SLIDING.

(d) 1860 kc OF SLIDING.

Figure 10 gives high magnification photomicrographs of interesting features found on the film wear track after various sliding intervals in dry argon. After 1 kilocycle of sliding (fig. 11(a)), the film on the wear track was smooth and continuous and the metallic substrate could not be seen. A few bubble-like protrusions could be seen after 1 kilocycle of sliding at the outer edges of the wear track (fig. 10(a)), and after longer durations of sliding these bubbles could be found also in the center of the wear track. Figure 10(b) shows one of these bubble areas in which the bubbles have cracked and spalled from the surface. These areas of bubbling, cracking, and spalling were localized and most of the track remained smooth and continuous. Since no change occurred in color (i.e., they remained metallic colored and did not turn black), it is surmised that no transformation of MoS_2 was occurring.

On continued sliding, the spalled areas tended to be self-healing; nevertheless, after long sliding durations (700 kc) the films started to thin in the center (fig. 10(c)). At failure (1860 kc of sliding), the wear track surface was covered with a coarse, powdery type of material. Thus, as found in moist air and dry air, failure was characterized by the buildup of a coarse, powdery film. In contrast to the air results though, this powdery debris was believed to result from the depletion of MoS_2 by the radial flow from the contact area rather than by depletion of MoS_2 by chemical transformation.

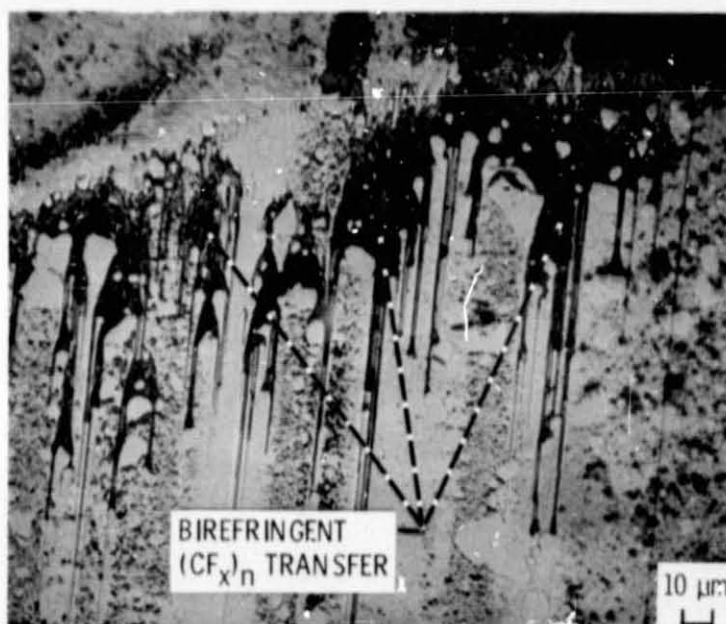
(a) RIDER WEAR SCAR.

Figure 13. - Photomicrographs taken after 100 kilocycles of sliding in a moist air atmosphere (10 000 ppm H₂O).

(b) $(CF_x)_n$ FILM WEAR TRACK.

Even though the film on the wear track was being depleted, the rider wear scar after 100 kilocycles did not look much different than it did after 1 kilocycle of sliding. The major difference is that the scar was larger and that there was less $(CF_x)_n$ in the inlet area. The transfer film on the rider looked about the same, with the exception that some birefringent $(CF_x)_n$ transfer was present.

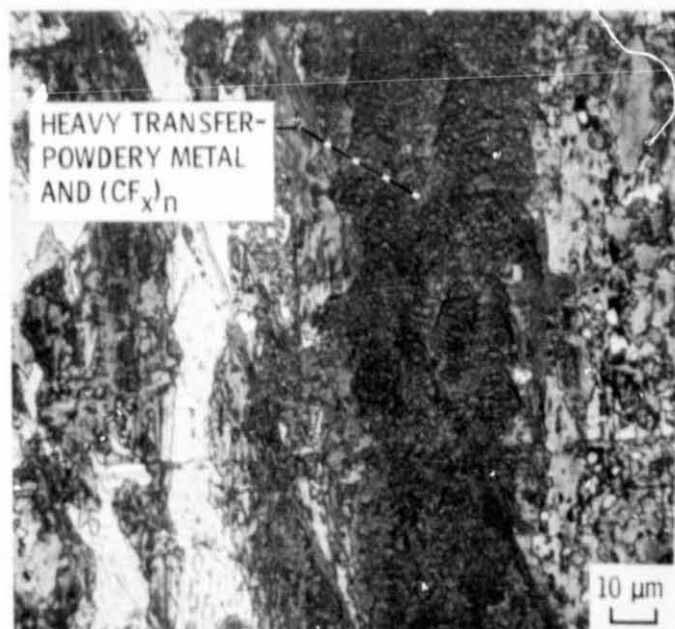
(a) RIDER WEAR SCAR.

Figure 14. - Photomicrographs taken after 308 kilocycles of sliding in a moist air atmosphere (10 000 ppm H_2O).

(b) $(\text{CF}_x)_n$ FILM WEAR TRACK

What happened to the surfaces when friction was gradually increasing was quite interesting. Figure 14 shows the surfaces at the time the friction coefficient reached a value of 0.20 (308 kc of sliding). Dark bands of heavy transfer were seen on both the rider wear scar and the film wear track. These bands were found to be a mixture of $(CF_x)_n$ and fine metallic wear particles. The formation of these bands was

believed to result from the depletion of $(CF_x)_n$ from localized regions in the film wear track. These regions generate excessive metallic wear particles which mix with $(CF_x)_n$ present in other regions to produce circumferential bands on the track.

High magnification observation of these bands indicated that even though they contained fine metallic debris, flow still occurred (fig. 14). After 380 kilocycles of sliding, however, the flow properties of the film (both on the rider and the disk wear track) were not nearly as good. Transfer became darker and more powdery. Examination of the wear areas under crossed polarizing filters, showed very few birefringent particles.

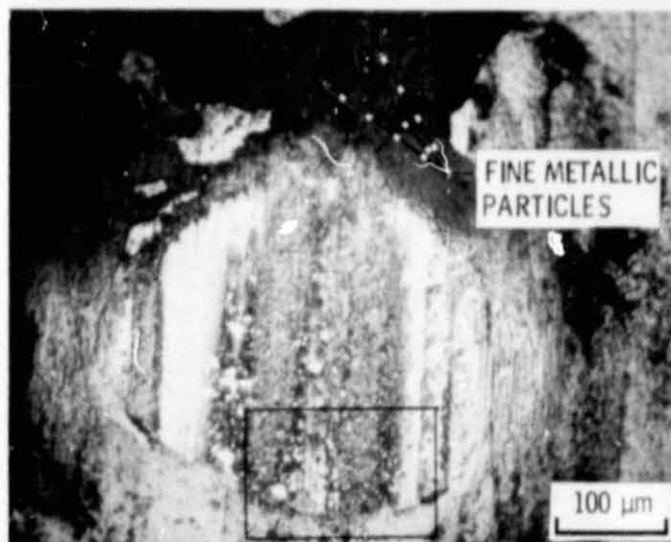
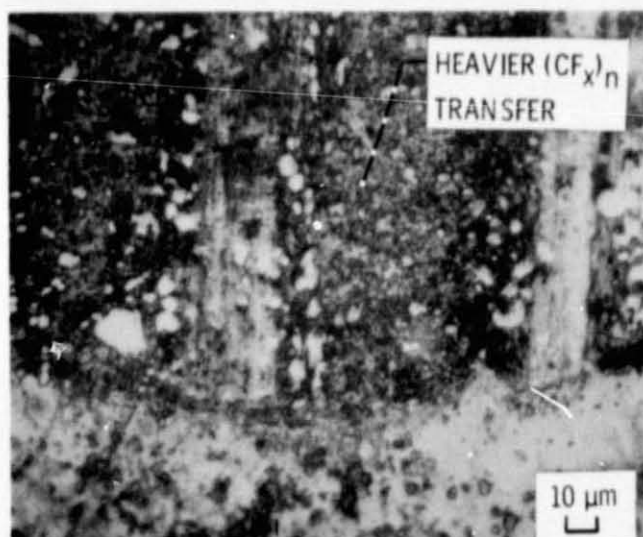
(a) RUN-IN PHASE, $\mu = 0.10$ (1/4 kc OF SLIDING).

Figure 16. - Photomicrographs of rider wear scars which slid on the graphite fluoride films shown in figure 15.

(b) LOW FRICTION PHASE, $\mu = 0.02$ (3 kc OF SLIDING).

(c) HIGH FRICTION PHASE, $\mu = 0.20$ (24 kc OF SLIDING).

Figure 16 shows photomicrographs of the rider transfer films which correspond to the intervals of Fig. 15. Compared to the moist air tests, the rider run in dry air had a thicker transfer film on it. Also there was more transferred $(CF_x)_n$ material at the sides of the wear scar than found for moist air tests. The difference in transfer may have been a contributing factor to the lower friction attained in dry air.

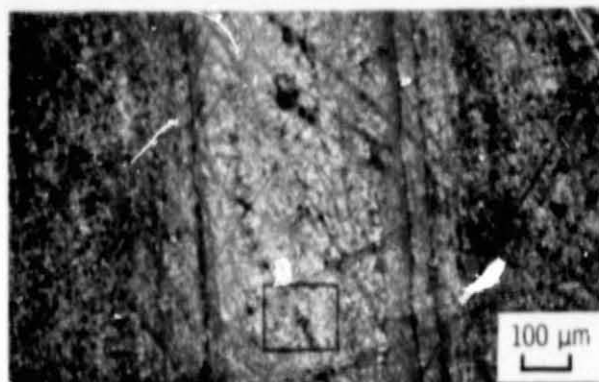
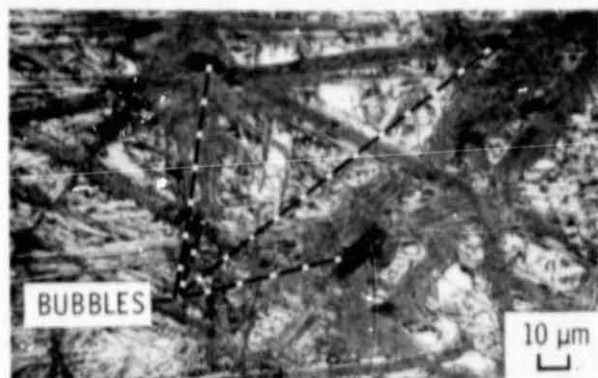
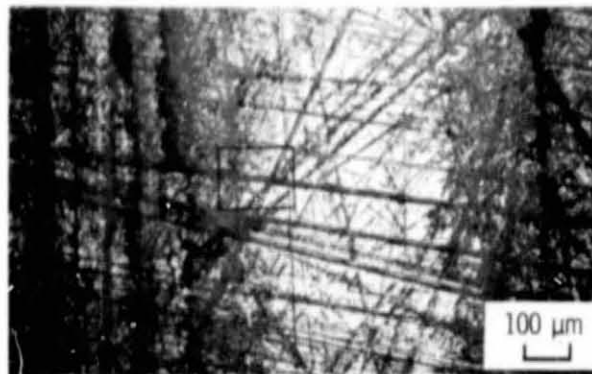
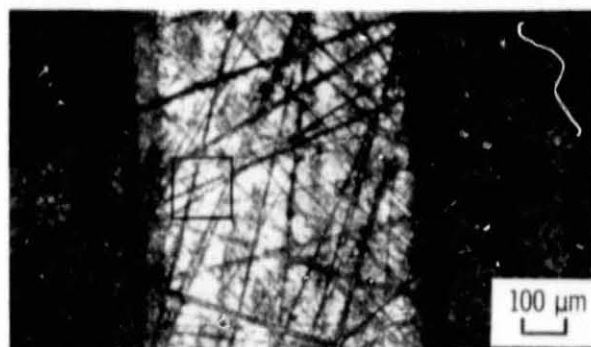
(a) 1kc OF SLIDING.

Figure 17. - Photomicrographs of a graphite fluoride film wear track after various sliding intervals in a dry argon atmosphere (< 20 ppm H_2O).

(b) 15 kc OF SLIDING.

(c) 60 kc OF SLIDING.

(d) 180 kc OF SLIDING.

The results from tests which were conducted in a dry argon atmosphere were very similar to those obtained in dry air. Rider wear scars, transfer films, and the $(CF_x)_n$ film near tracks did not look much different. Figure 17 gives photomicrographs of the film wear track after (a) 1, (b) 15, (c) 60, and (d) 180 kilocycles of sliding. The same general film wear process (as was found in moist air or in dry air) was found to also occur in dry argon, and that was a gradual depletion of the $(CF_x)_n$ from the contact region.

One difference between the dry air and dry argon tests was that the $(CF_x)_n$ did not as readily disengage from the scratches, and this most likely was the reason for the longer life in dry argon. Another difference was that heavy bands of transfer did not form on the surface of the rider or the disk wear track when high friction occurred as it did in moist air and in dry air. Some disengagement from the scratches did occur in the form of small bubbles as can be seen in Fig. 17(b).
